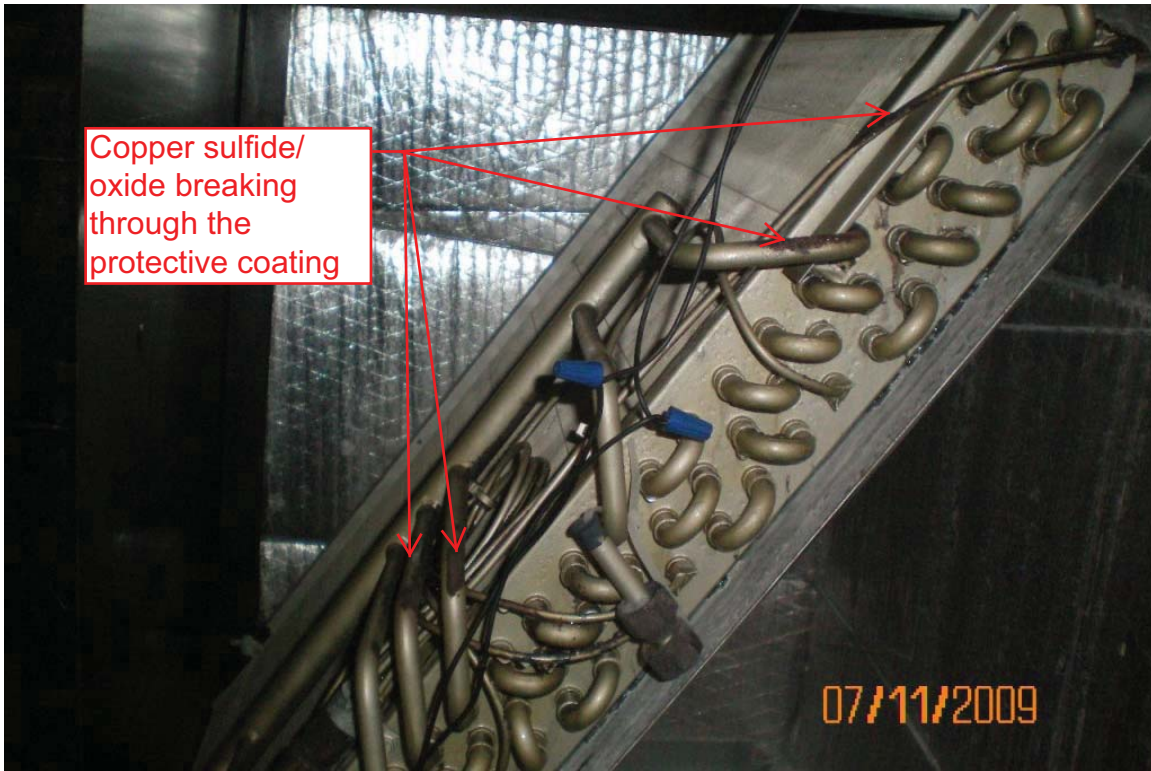
Coated coil installed in April of 2009. Picture taken July 11, 2009.

Picture is from 1,400 sf townhouse with tainted Chinese drywall throughout the walls and a mix of 5/8" non-tainted and 1/2" tainted drywall on the ceilings.
