Field study to determine effectiveness of teflon coating as a means to protect or extend the life of evaporator coils in a home containing tainted Chinese drywall.

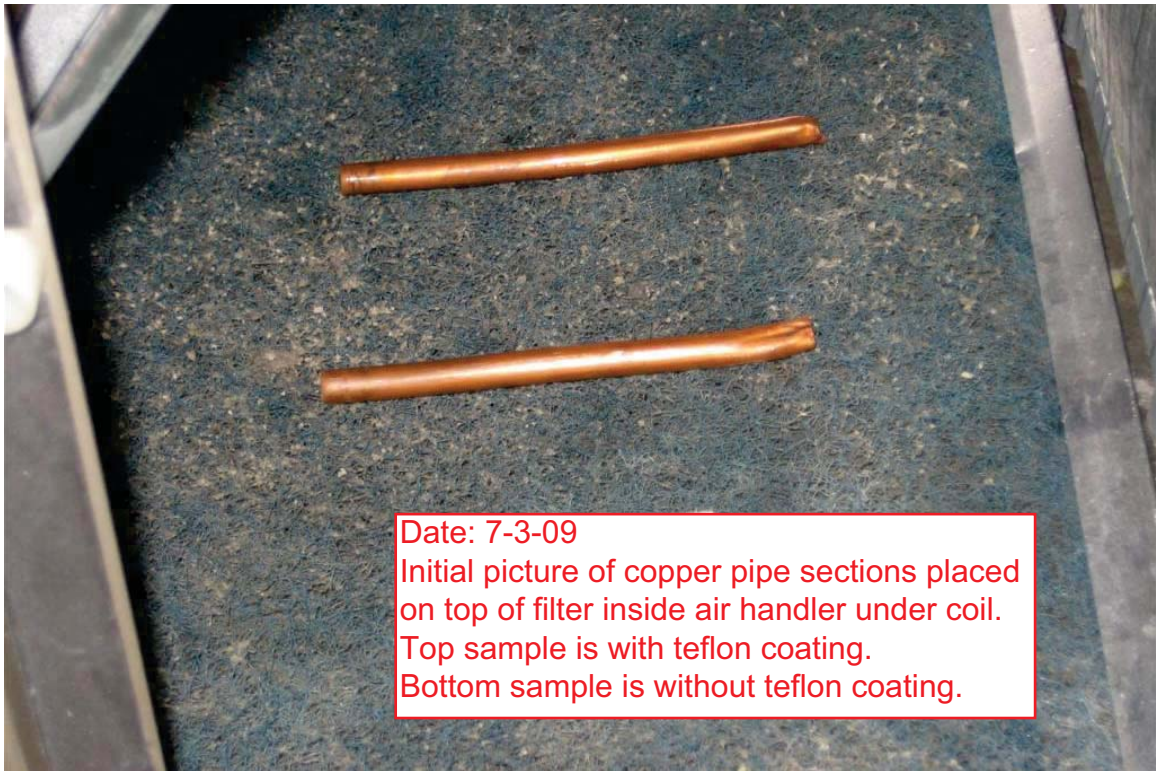
Date: 7-3-09  
Initial picture of copper pipe sections placed on top of filter inside air handler under coil.  
Top sample is with teflon coating.  
Bottom sample is without teflon coating.

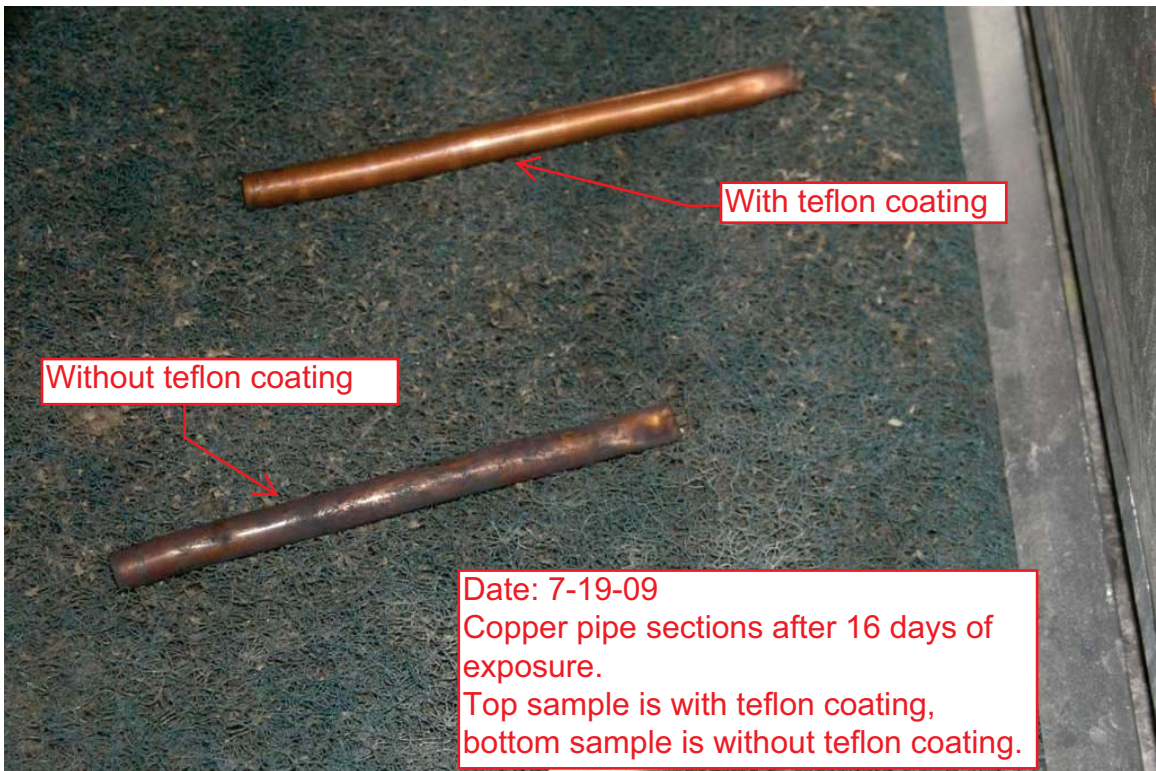
Date: 7-19-09  
Copper pipe sections after 16 days of exposure.  
Top sample is with teflon coating,  
bottom sample is without teflon coating.
